Sample Cottage Watch Report

Cottage Watch Report

August 12, 2026 · Lake Muskoka · Inspector: Muskoka Watch

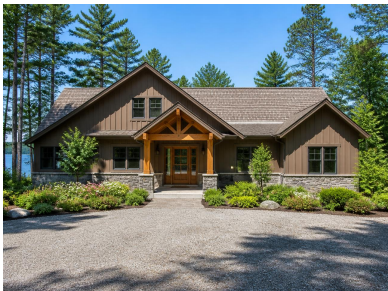
Front of Cottage

Front entrance and facade, no signs of forced entry.

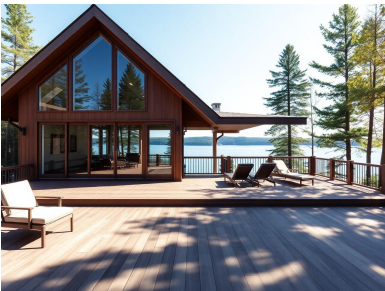
Rear Elevation

Rear wall and lake-facing doors, siding intact.

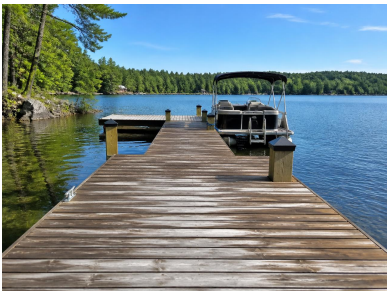
Dock structure secure, no loose planks or shifting.

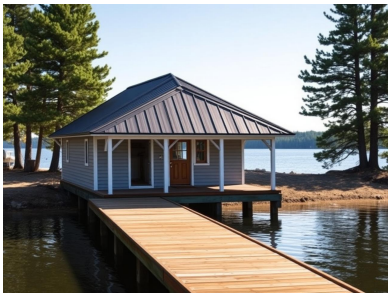
Boathouse and slip in good condition.

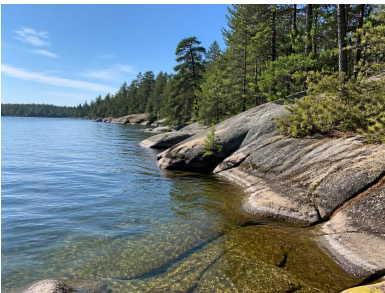
Shoreline

Waterline stable, no erosion or flooding observed.

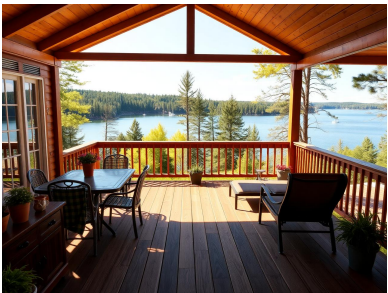
Deck sound, railings secure, surface dry.

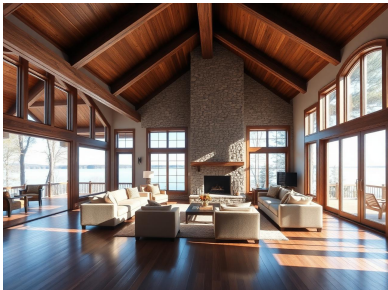
Living Room

Interior dry, no moisture or damage detected.

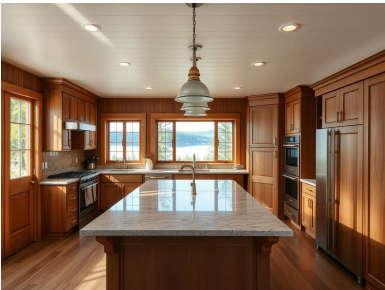
Kitchen

Appliances off, no leaks under sinks.

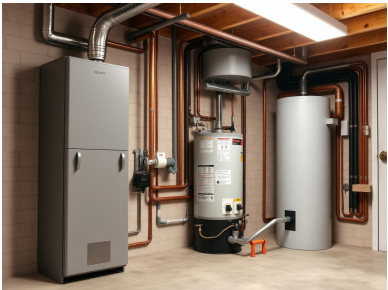
Mechanical Room

Furnace and water heater operating normally.

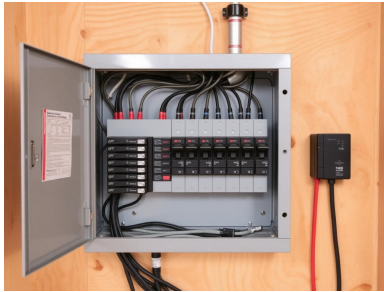
**Electrical Panel**

Breakers nominal, no tripped or flagged circuits.

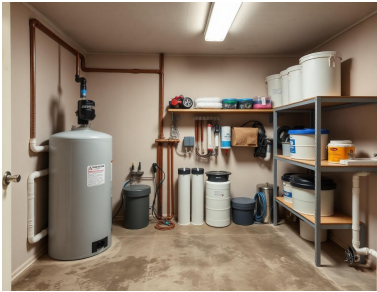
**Utility Room**

Pressure tank and pump operating within range.

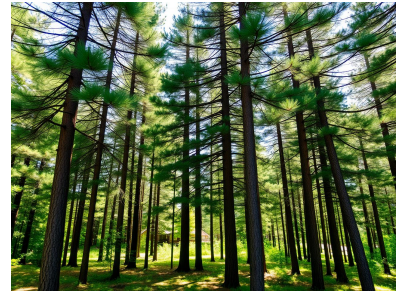
**Trees**

Surrounding trees healthy, no limbs threatening the roof.

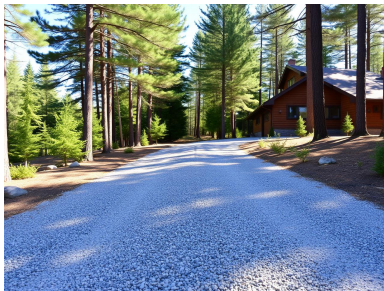
**Driveway**

Surface clear, no washout or obstruction.

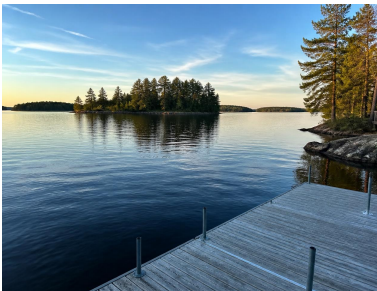
**Waterfront**

Lakefront view confirming dock and shoreline condition.

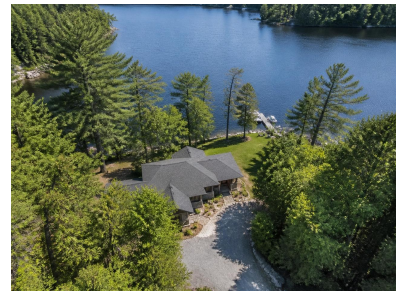
**Property Overview**

Full property exterior, grounds in excellent order.
